## Why does the old version Slim Jr. flicker?

## How was the design of Slim Jr. modified to eliminate the flickering?

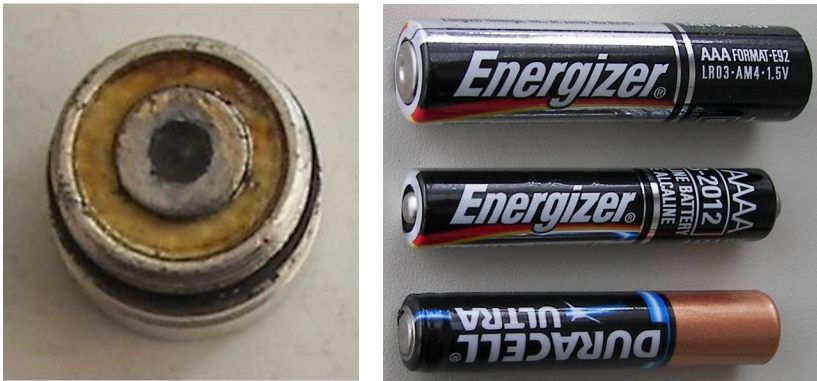
The picture below is a returned flickering Slim Jr. LED. This LED is our original version, (sold before Jan. 1<sup>st</sup>, 2008). The center, where the soldering hole is located, is heavily contaminated. It could be oxidation of the soldering surface or just build-up when contacting the negative pad of the battery. We used Energizer AAAA batteries. The negative contact is rounded, so that it can only contact the center area of the LED pad where the soldering hole located. The contact between the batteries and the LED cannot be good unless the build-up was scratched off. Duracell AAAA battery has a flat negative contact that also contacts the copper pad around the soldering hole, so it may work better than Energizer battery.

However we have modified the design of the LED head to eliminate the flickering caused by the contact between the battery and the LED. We added a nickel-plated copper pad on the top of the original contact pad, as shown in the picture below. This flat copper pad allows better contact with the Energizer AAAA. In addition, the nickel-plated surfaces are not easy to be oxidized. This will greatly reduce the maintenance the end user needs to perform. All Slim Jr. sold after Jan. 1<sup>st</sup> 2008 using this new LED head.

Please take the following three steps to fix the flickering:

1. Scratch off the oxidized layer on LED contact pad.
2. Wipe clean both contacts of batteries. New batteries may have dust on the contacts.
3. Add a contacting PCB (shown below) between the battery and the LED.

With the contacting PCB, it is not necessary to clean the indented hole in the center of the LED contact pad. However it is necessary to scratch off any contamination on the flat surface to ensure good contact between the contacting PCB and the LED.

Because the contact between the PCB and the LED contact pad are copper-to-copper contact, further oxidization will be eliminated. With the contacting PCB, it works the same as the new LED head.
